# Inspectec<sup>LLC</sup>

## Residential Property Inspection Report

123 First Street  
Westlake, Ohio 44145

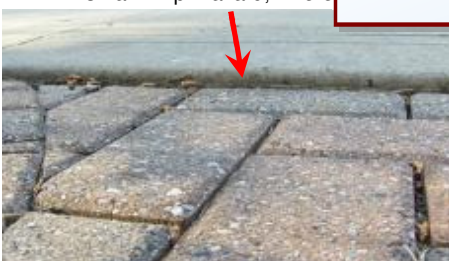
~The driveway has a "less than average" amount of cracking and an "above average" amount of spalling for its age.

\*Spalling or "flaking" of concrete is usually a result of our freeze/thaw cycles which contracts/expands concrete. Some minor spalling is normal. Excessive spalling could be the result of several conditions; an improper concrete mixture, improper installation, or by concrete that was too wet when poured. "Sealing" concrete may help curtail spalling. Concrete "sealers"

Concrete "spalling".

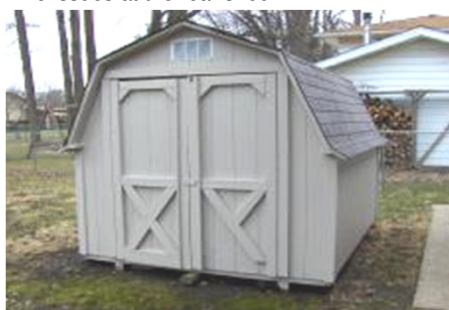
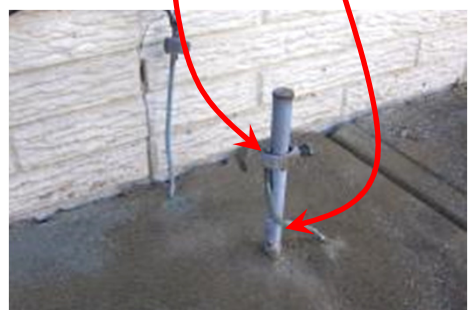
▶ A "grounding rod" extends up too high and is unsafe.

This condition is a hazard.

This "grounding rod" needs to be cut down, and the grounding clamp & wire, moved to the bottom.

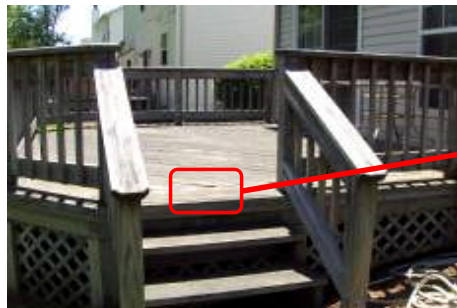
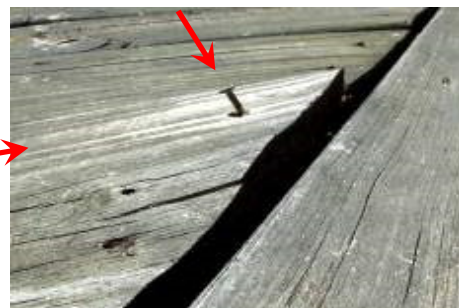
~The deck has no major safety problems but is very old and nearing the end of it lifecycle. At the least, It will need a few repairs for safety.

~The deck wood has some drying wood and splintering. Make needed repairs (you may want to replace some of the boards) and seal wood.

Re-set any raised nails.

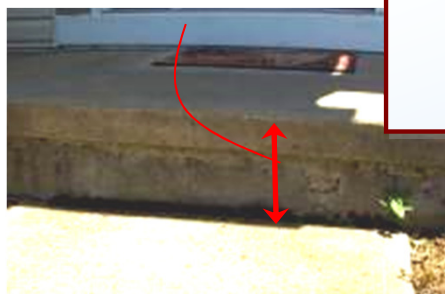
~ The front setp is a bit too "high". This is due to a "settled down" walkway. As we discussed, you could have "concrete pumping or lifting" done to "raise the settled down walkway".

Step up, is too high.

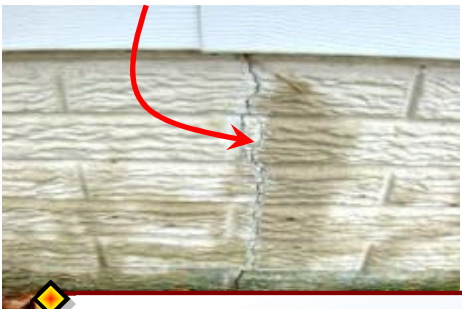
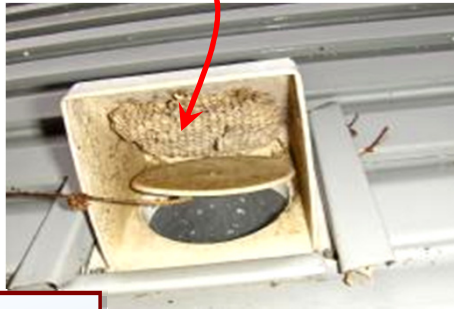
Foundation Crack, Should be filled / sealed & monitored.

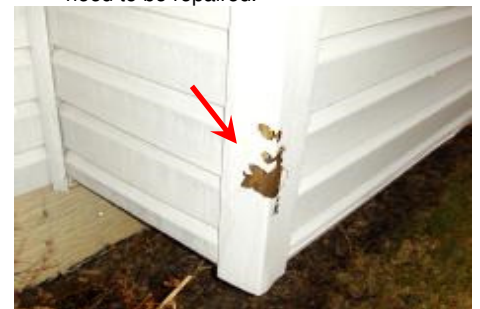
Some damage at the rear siding will need to be repaired.

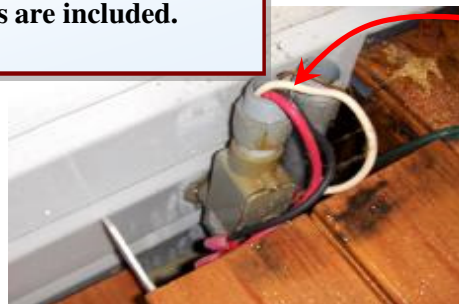
These electrical feed wires appears to have been from a past (removed hot tub panel). The breaker feeding this is turned off, but these wires will need to be removed, or an electrical box will need to be installed here, for these wires to properly terminate in.  
As is, this is dangerous.

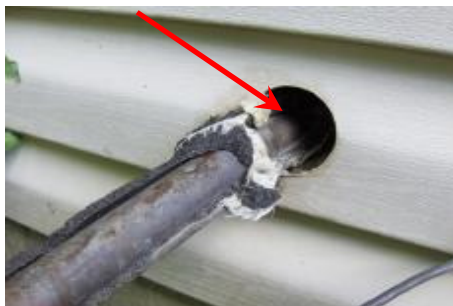
Gap where lines enter the home

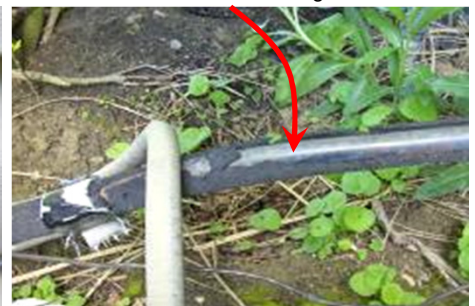
- ~The air conditioning cooling line insulation is deteriorating / missing. Bad or missing insulation will cause the unit to be less efficient. New foam insulation can be purchased at local home improvement stores and is an easy installation.

Bad insulation on cooling line

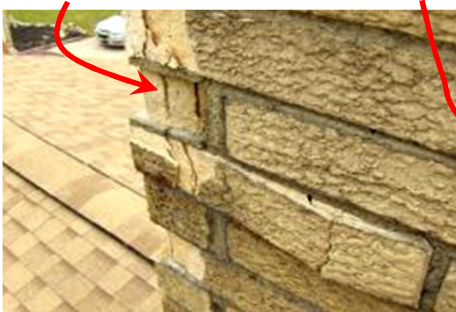
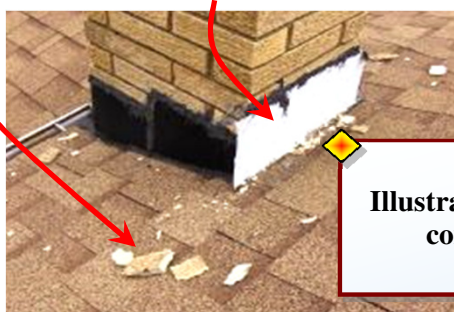
▶ Chimney has some CRACKED / DAMAGED bricks.

"Freeze Damaged" Chimney Bricks. "Flaking" from bricks. Poorly installed "flashings".

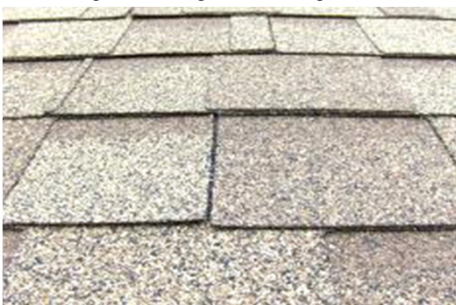
Shingles are in good / average condition.

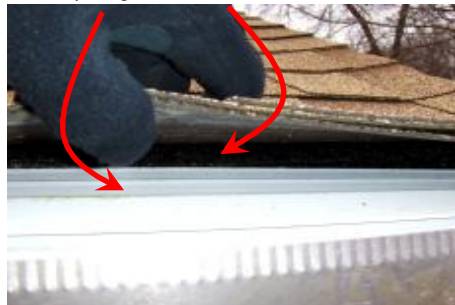
Drip Edge & Ice Guard. Both Observed

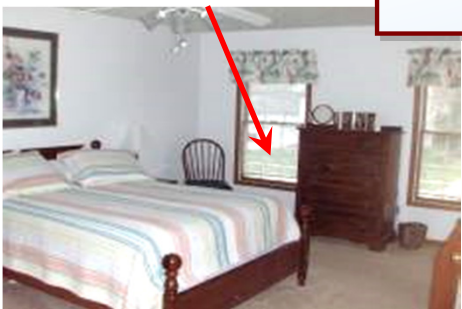
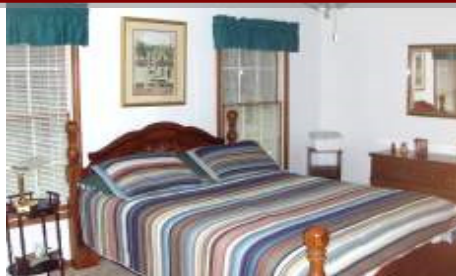
Windows Meet Egress Standards

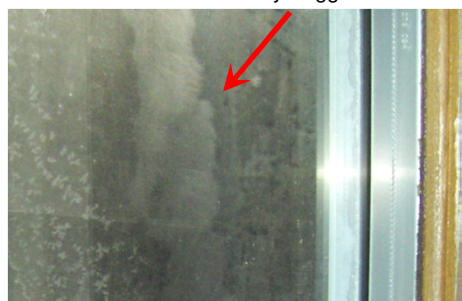
One rear BR window is badly "fogged" inside.

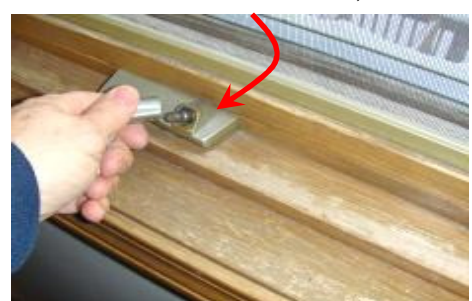
Several window handles are loose, or come off.

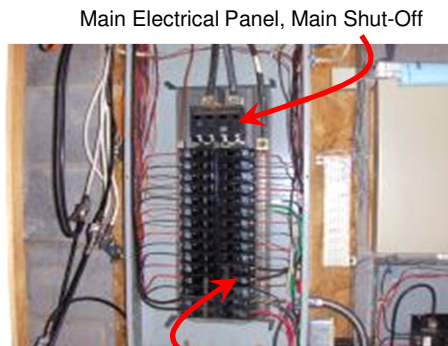
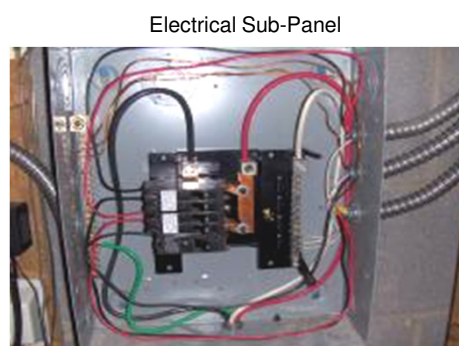
~This electrical sub panel was observed with isolated neutrals, and overall properly wired. No major problems were observed however, circuits are not all properly labeled properly, but should be for safety.

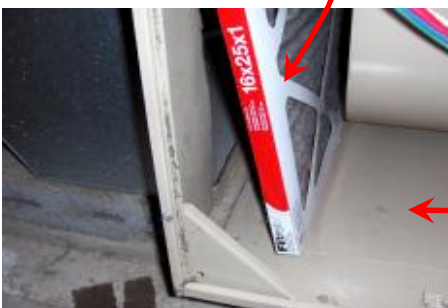
- ~The furnace filter is improperly and/or poorly installed. It should be reconfigured as to not a
- ~ Cleaning of the furnace is also needed as dust has been bypassing the furnace for a long t

Filter needs to be "Re-Configured" so air will not bypass it.
